THE PERFORMANCE OF RAILWAY EMBANKMENT STABILISATION MEASURES

Dr Derek Egan
Senior Design Engineer
Keller Ground Engineering
Thorp Arch Trading Estate
Wetherby, LS23 7BJ

Mark Rudrum
Associate
Ove Arup & Partners
13 Fitzroy Street
London, W1P 6BQ

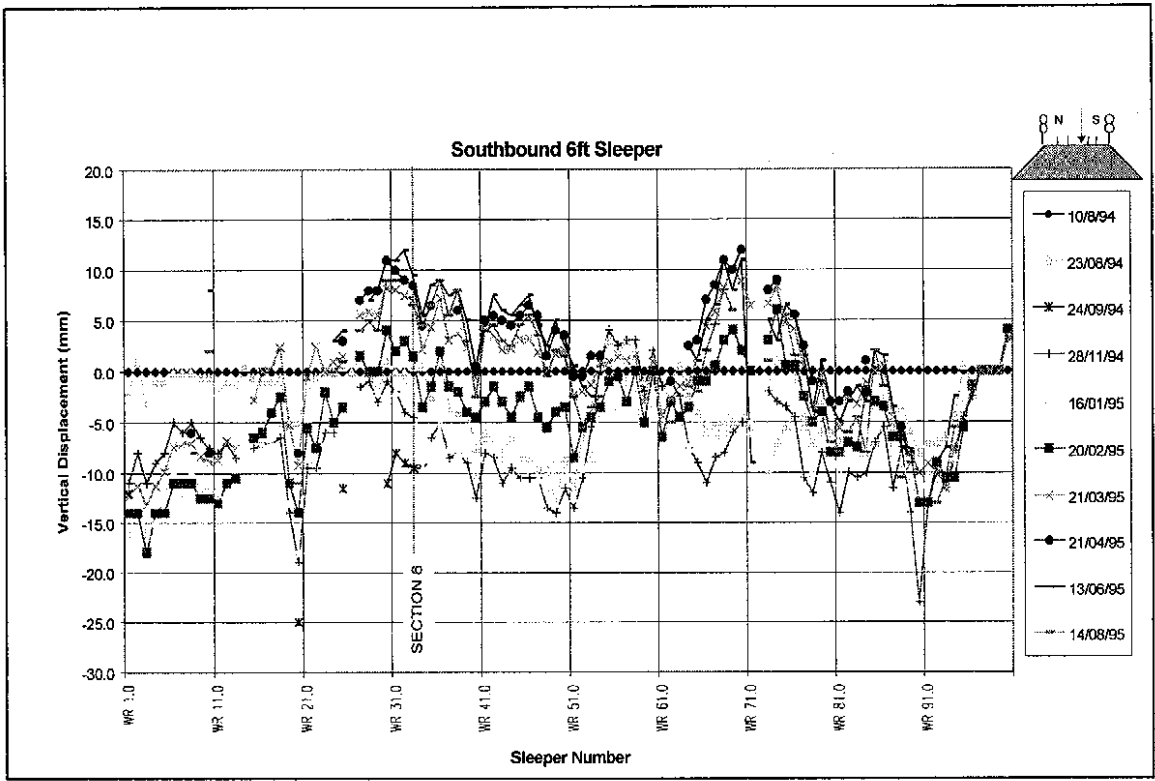
Figures 2 and 3 show the pre-remedial works monitoring data around Section 6, obtained by optical levelling the end of the sleepers adjacent to the 6 ft, (unfortunately similar data for Section 2 are not available). For the twelve months prior to construction of the remedial works the maximum recorded deviation sleeper level ranged from -17 mm (settlement) to $+12$ mm (heave) as shown in Figure 3.

Figure 2 Burnt Oak Pre-remedial works track levelling data (Movement of Southbound Rail with time)

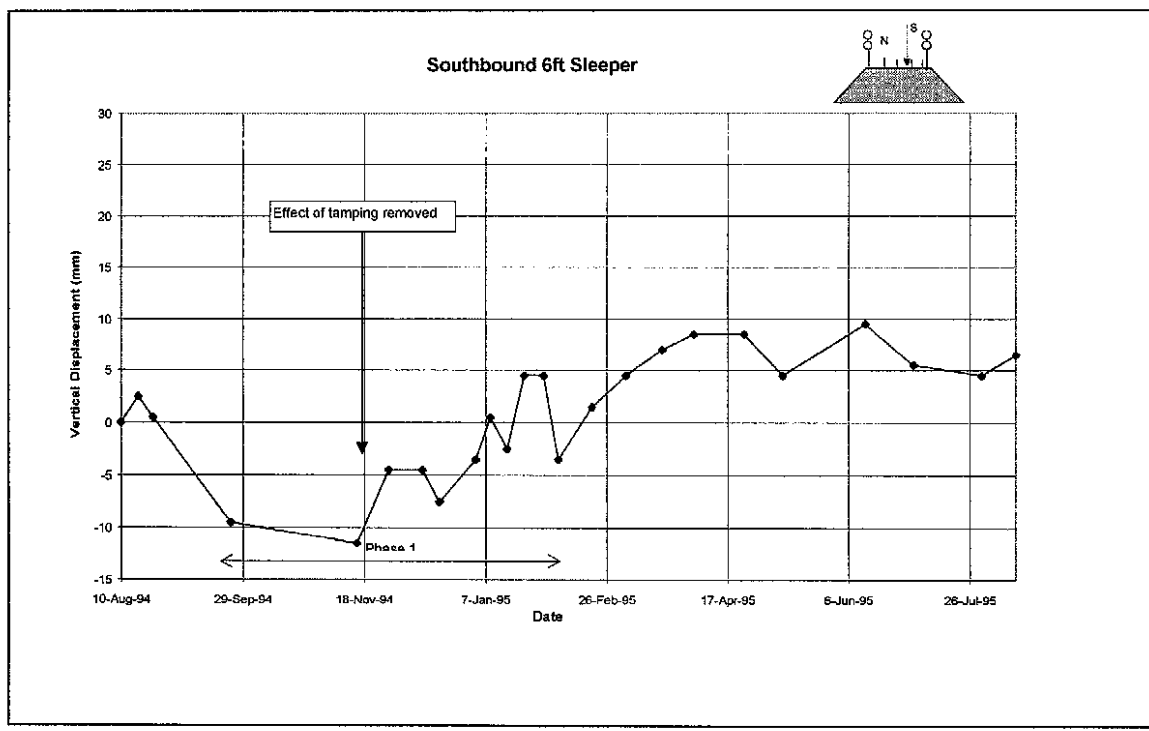
Figure 3 Burnt Oak Pre-remedial works change in Southbound sleeper level with time at Section 6

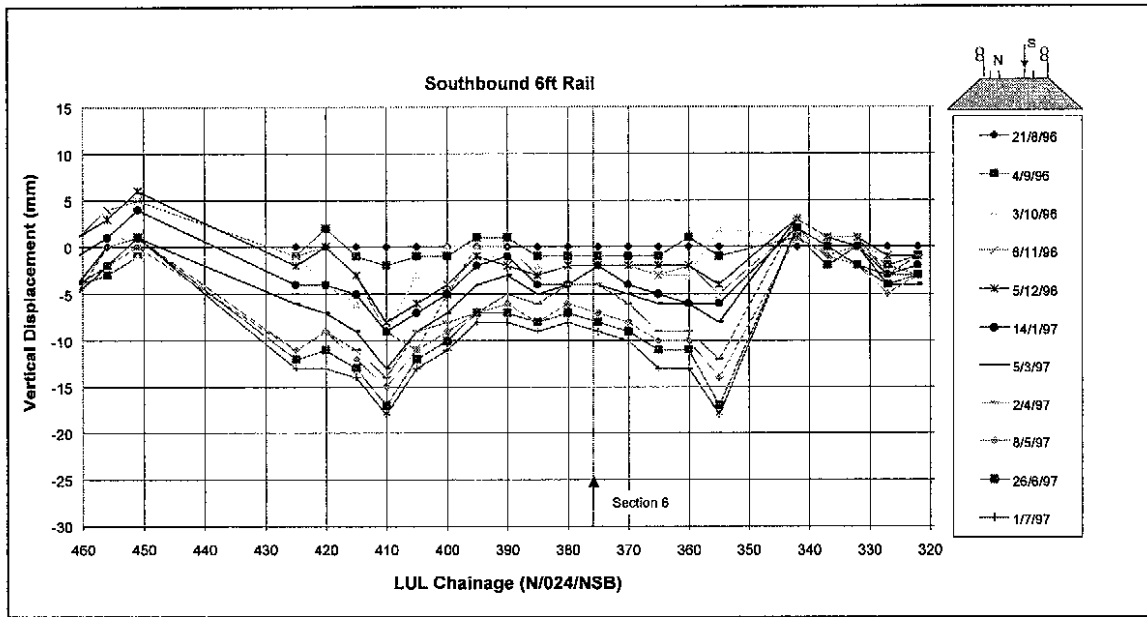
Figure 4 Burnt Oak Post-remedial works track levelling data (Movement of Southbound Rail with time)

Post construction monitoring was carried out on a monthly basis by levelling the top of the rails at 5m intervals of chainage. Figure 4 shows the recorded rail levels with time on the Southbound. Figure 5 shows the recorded change in rail level with time for both North and Southbound track at Section 6.

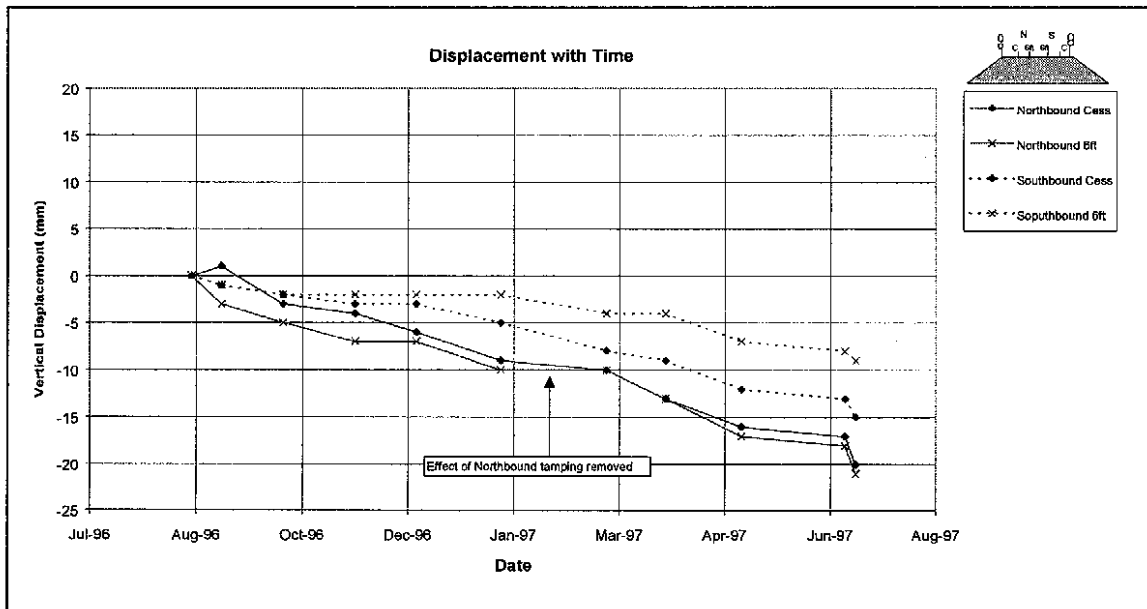
Figure 5 Burnt Oak Post-remedial works change in rail level with time at Section 6

It should be noted that these data have been corrected to remove gross displacements resulting from re-ballasting, tamping and associated track works. Data for Section 2 has been omitted due to spec restrictions here, but at both sections the tracks showed a general trend of settlement of the order of 9mm to 20mm at Section 6 and 4mm to 9mm at Section 2.

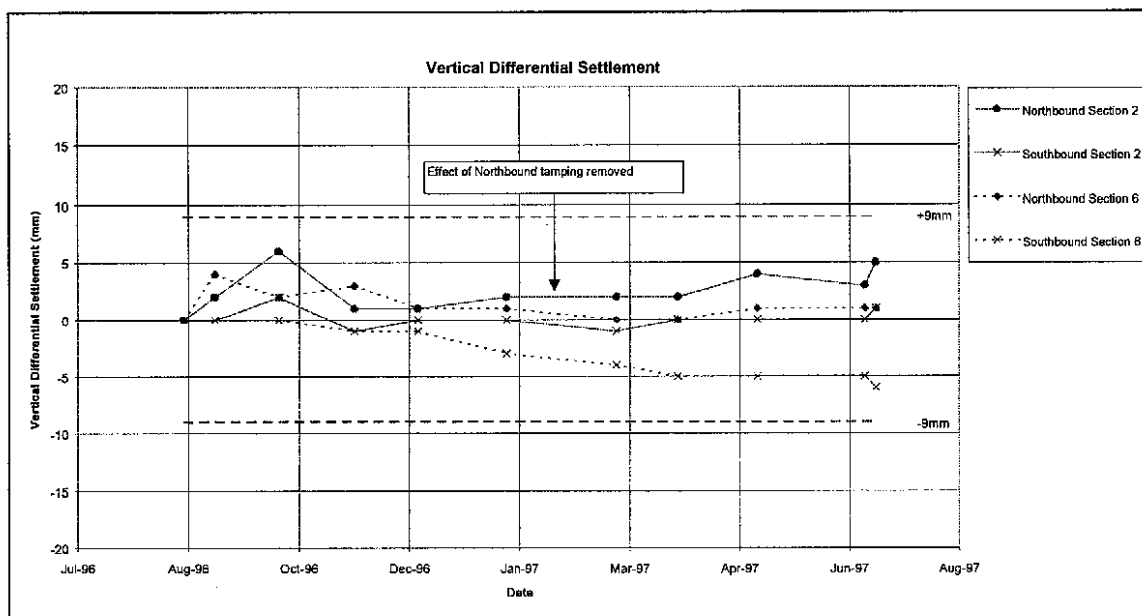
Figure 6 shows the differential settlement of the cess rail with respect to the 6ft rail (i.e. change in cant) with time for the two sections. For these data negative differential settlement indicates the cess rail is settling with respect to the 6ft rail. All data show the observed deformation to be within the LUL track geometry requirements.

Figure 6 Burnt Oak – Post –remedial works change in cant with time at Sections 2 and 6.

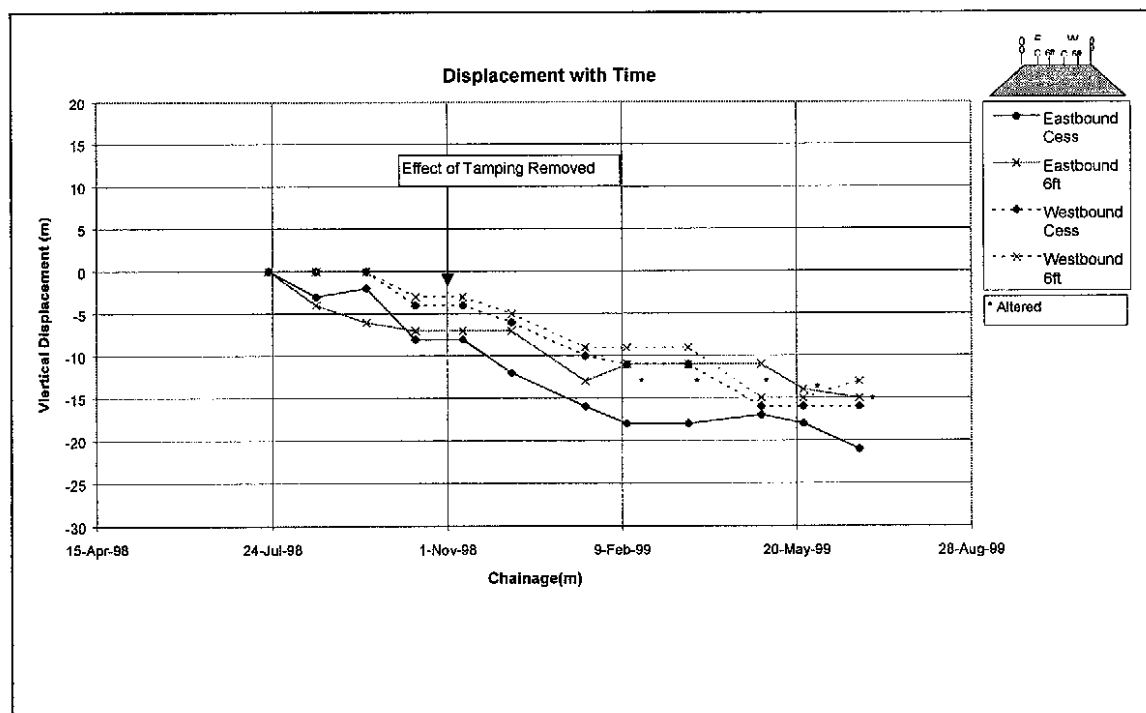
Figure 7 Arnos Grove – Post remedial works change in rail level with time on Eastbound and Westbound.

Figure 7 shows the change in rail level with time for typical cross sections through the propped mini pile structure on the Westbound and the gabion/regrading solution on the Eastbound. These data show a trend of settlement of approximately 20mm settlement of the embankment occurring over the 12 month monitoring period. However, the maximum differential settlement (change in cant) during the 9 month period was only about 4mm on the Westbound (mini-pile wall) and 8mm on the Eastbound (Gabion/regrading).

Data obtained adjacent to the gabion / regrading solution at Arnos Grove shows the cess rail settling by up to 8mm with respect to the 6ft rail during the 12 month monitoring period. This is more than observed adjacent to the structural mini pile solution (4mm). While both solutions achieved the requirements of the LUL specification, the monitoring indicates that gabion and earthworks solutions are more flexible and do not offer the same degree of support as the structural solution. Similar conclusions could be drawn from Andrei (1999), who published data for a site at Rayners Lane on the LUL network.

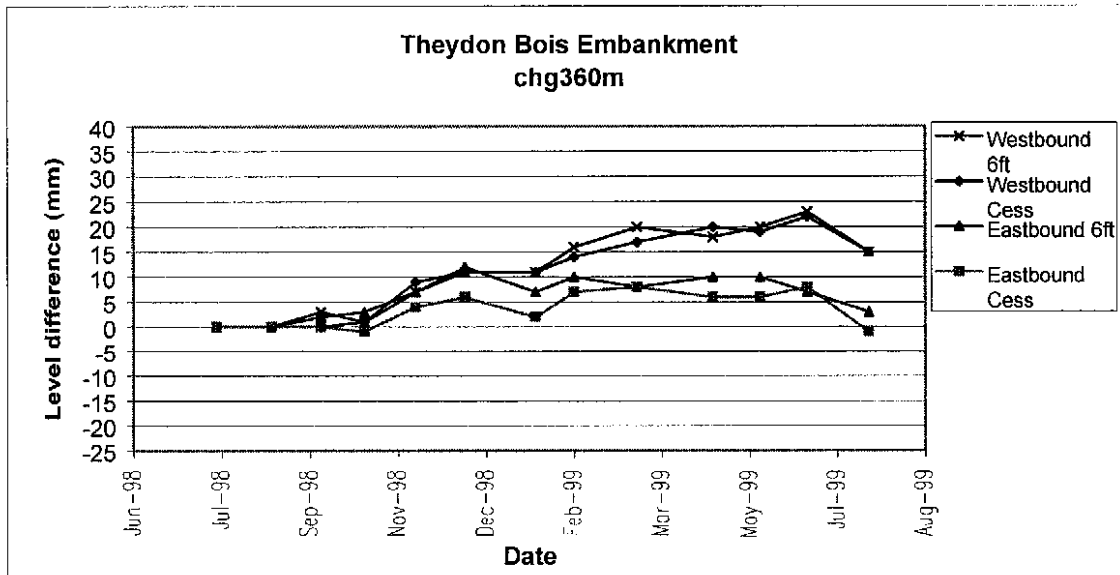
Figure 8 Theydon Bois, Post remedial works change in rail level with time on Eastbound and Westbound

Figure 8 shows the change in rail levels over the post construction monitoring period for a cross section taken midway along the length of the embankment. This data shows a heave of approximately 20mm and 10mm for the Westbound and Eastbound tracks respectively. Figure 9 shows the vertical differential settlement of the outer rail with respect to the inner rail (i.e. change in cant) with time at the same cross section.

The behaviour at Theydon Bois is notably different to the other sites, as shown in Figure 8, with both the Eastbound and Westbound tracks recording heave during the post construction monitoring. While the cause of this difference in behaviour might be related to a number of factors it is likely that the effect of removing all of the mature tree cover that existed on both sides of the embankment prior to the construction works at this site is significant. It is well known that high plasticity soil are prone to swelling where trees have been removed.

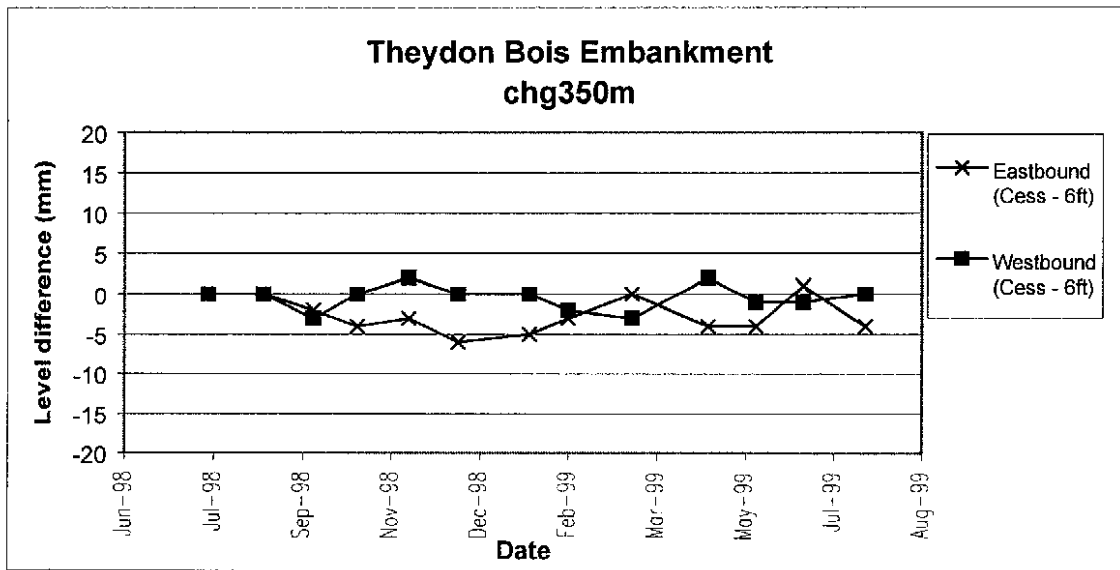
Figure 9 Theydon Bois – Post remedial works change in cant with time on Eastbound and Westbound
