CASE STUDY

St Martin's Church, Welton

Structural monitoring of St Martin's Church.

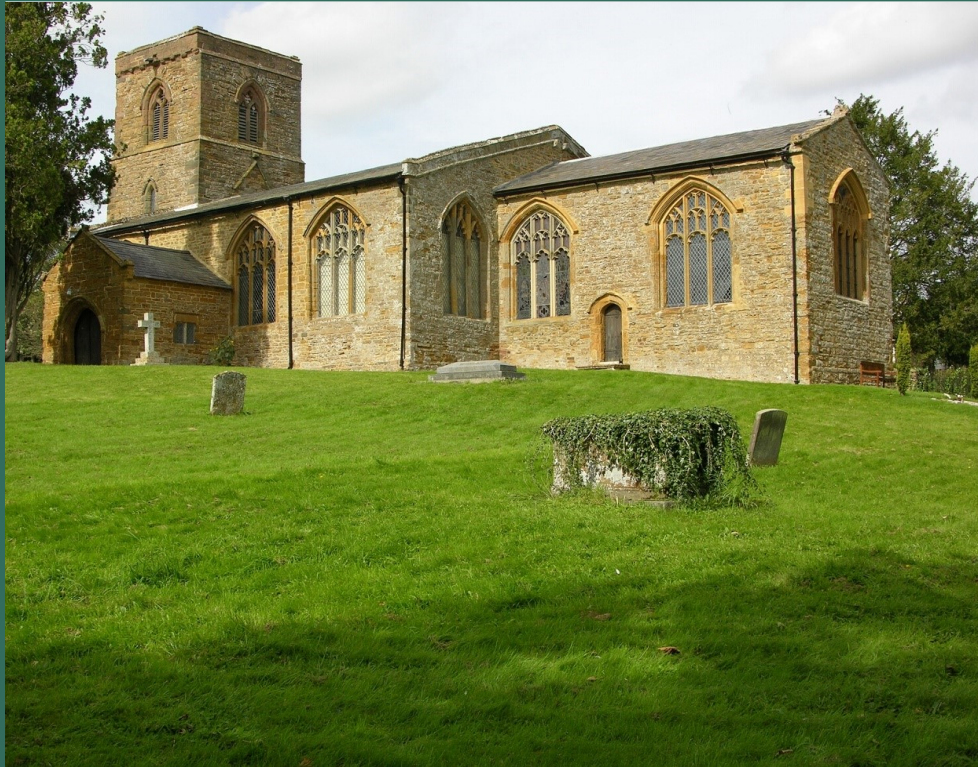
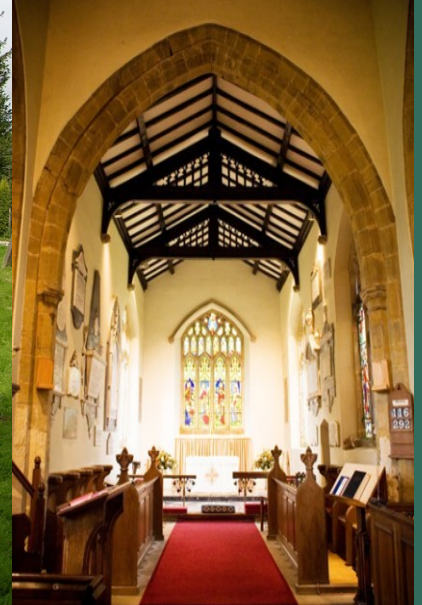
Existing cracking patterns have been

visually surveyed, with accompanying photographic record, and structural monitoring implemented on the most serious cracks. Regular three monthly data collection is now being undertaken.

Installation and monitoring of steel monitoring studs to measure seasonal and long term variation in structural cracking.
