THE PERFORMANCE OF RAILWAY EMBANKMENT STABILISATION MEASURES

Dr Derek Egan
Senior Design Engineer
Keller Ground Engineering
Thorp Arch Trading Estate
Wetherby, LS23 7BJ

Mark Rudrum
Associate
Ove Arup & Partners
13 Fitzroy Street
London, W1P 6BQ

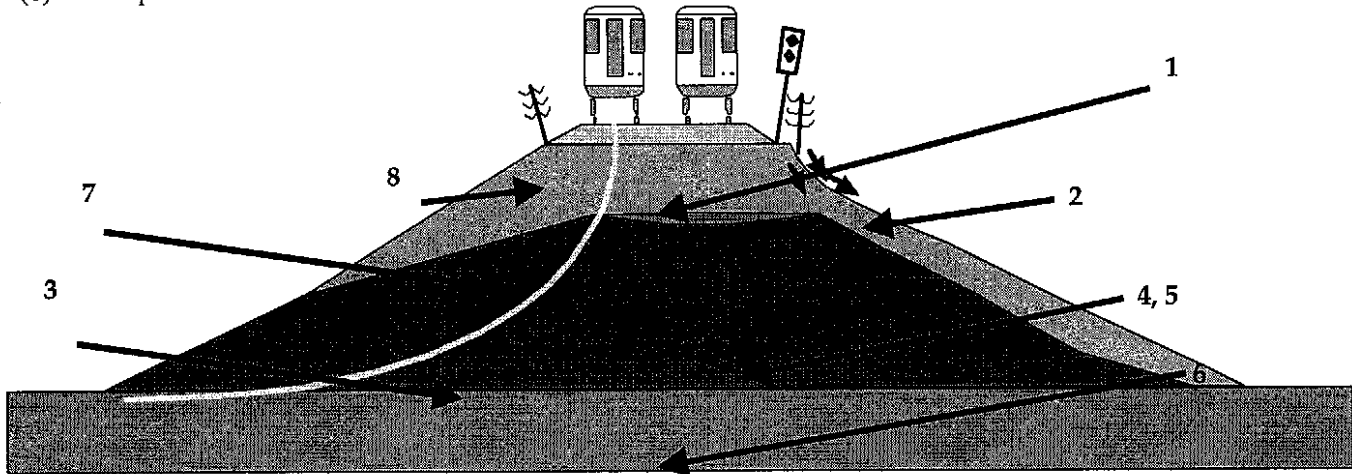
- (1) Track bed / formation (and ponding).
- (2) Shallow slope instability (e.g. at ash fill / ballast shoulders).
- (3) Deep seated slope instability.
- (4) Seasonal desiccation / swelling from tree roots / vegetation.
- (5) Settlement from inadequate compaction and inhomogeneous fill.
- (6) Poor foundation.
- (7) Internal erosion / burrows.
- (8) Inadequate cess.

Figure 1 Generic embankment 'failure mechanisms' (After McGinnity, Fitch, Rankin 1998)

Post construction monitoring indicates that at all the sites there was still some ongoing settlement / heave of the tracks even after construction of remedial works. It is thought that this reflects the fact that the schemes address the primary causes of instability / movement but movement due to secondary causes (see Figure 1) cannot be fully eliminated.
